Case Study: Energy Audit of the High School Dorm “Mirka Ginova”- Bitola

Vladimir Mijakovski¹, Vangelce Mitrevski² and Tale Geramitcioski³

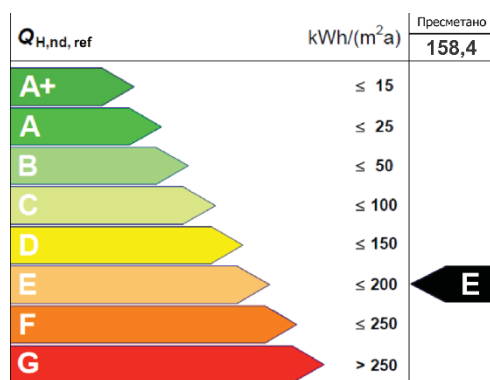
Fig. 4. Calculated energy class of the building

The results from the calculations categorized the building of the High school dorm "Mirka Ginova" – Bitola as class "E" building. Calculated value of energy consumption is 158,4 kWh/(m²a).

According to the National legislative, [2], all buildings undergoing 'substantial reconstruction' must reach at least "D" energy class.

- Thermal insulation of all external walls in order to reach maximum allowed U-value of 0,35 W/m²K;
- Partial replacement of windows and carpentry in order to reach maximum allowed U-value of 1,7 W/m²K;
- Installation of additional thermal insulation for the roof in order to reach maximum allowed U-value of 0,25 W/m²K;
- Replacement of one of the hot water boiler running on light oil fuel with high efficiency hot water boiler running on wood pellets.
- Replacement of light bulbs and fluorescent lighting tubes with LED lights;

Implementation of these measures would 'raise' building's energy class to "C".
